Inspection Report

Sample Report 1

Property Address:
456 Inspection Lane
Charleston SC 29403

Step By Step Inspections, LLC

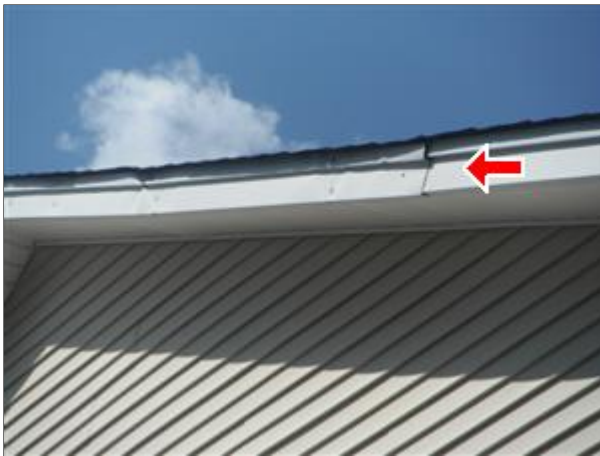
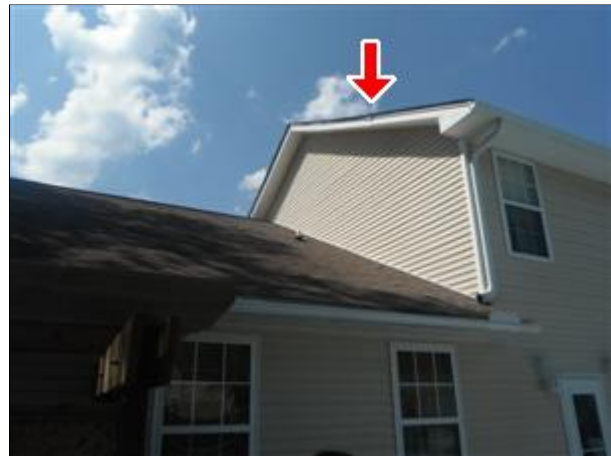
2.1 Picture 1

The metal fascia wrap at eave on the rear of home right side (facing front) is loose. Rain can enter behind this area and deterioration may occur to the structure behind the wrap if not corrected. A qualified person should repair or replace as needed.

The metal fascia wrap at eave on the rear of home right side (facing front) is loose. Rain can enter behind this area and deterioration may occur to the structure behind the wrap if not corrected. A qualified person should repair or replace as needed.

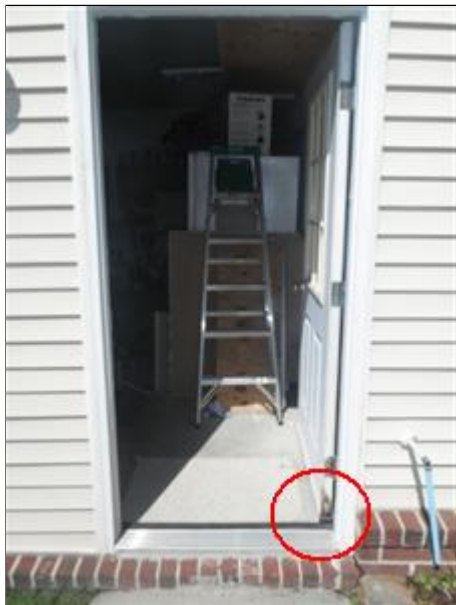
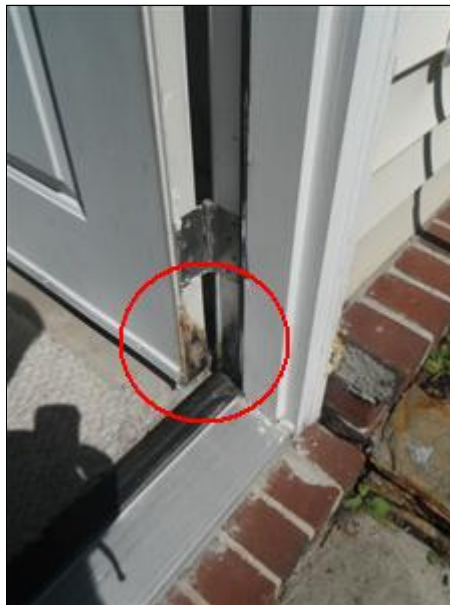
2.2 Picture 1

🔧 The side entry door to the garage is deteriorated at bottom of jamb (s) and bottom end of the door. Further deterioration may occur if not repaired. A qualified person should repair or replace as needed.

The side entry door to the garage is deteriorated at bottom of jamb (s) and bottom end of the door. Further deterioration may occur if not repaired. A qualified person should repair or replace as needed.

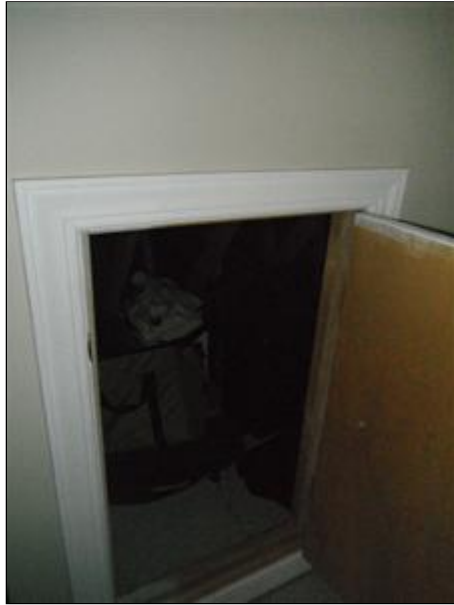
4.5 Picture 1

The attic access door is missing weather-stripping at the room above the garage. This can cause some heat loss in winter and loss of cool air in summer if not corrected. This is a maintenance issue and is for your information. I recommend repair as desired.

The attic access door is missing weather-stripping at the room above the garage. This can cause some heat loss in winter and loss of cool air in summer if not corrected. This is a maintenance issue and is for your information. I recommend repair as desired.

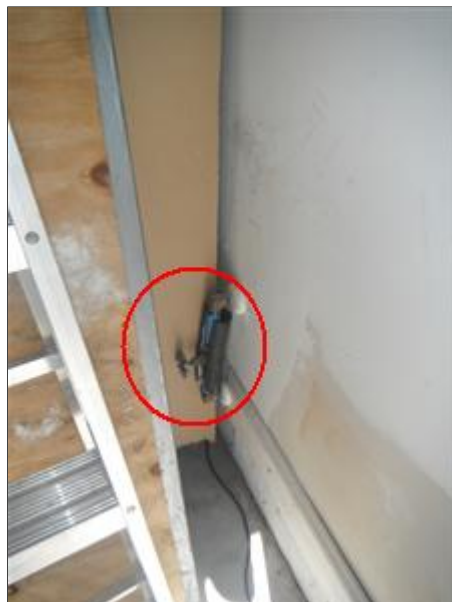
6.3 Picture 1

The main shut off is the knob located in the garage. This is for your information.

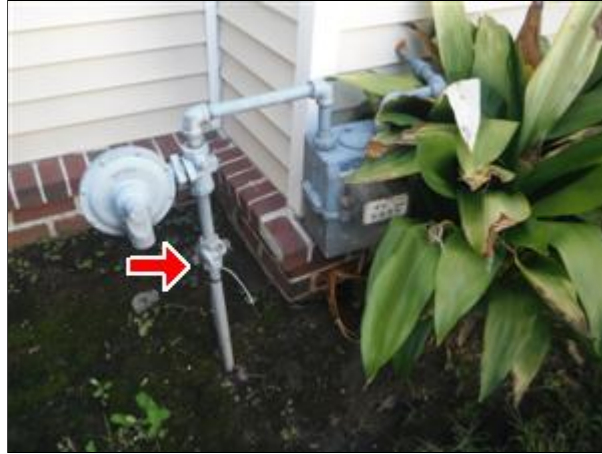
6.5 Picture 1

The main fuel shut off is at gas meter outside

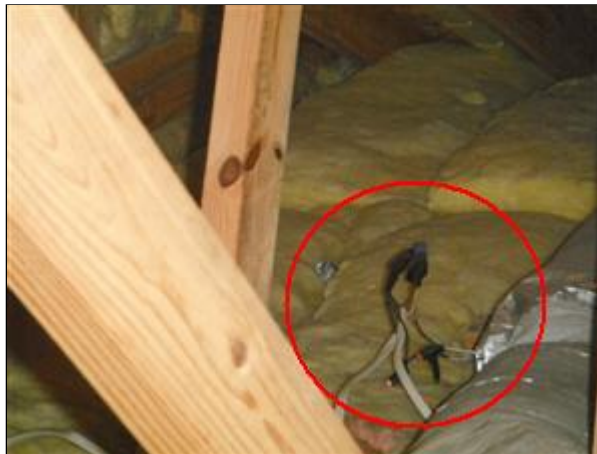
7.3 Picture 1

+ Two loose wire splice need placing in boxes with cover-plates above the Master bedroom in attic. Exposed wiring is considered a fire/shock hazard until repaired. I recommend a qualified licensed electrical contractor correct.

+ Two loose wire splice need placing in boxes with cover-plates above the Master bedroom in attic. Exposed wiring is considered a fire/shock hazard until repaired. I recommend a qualified licensed electrical contractor correct.

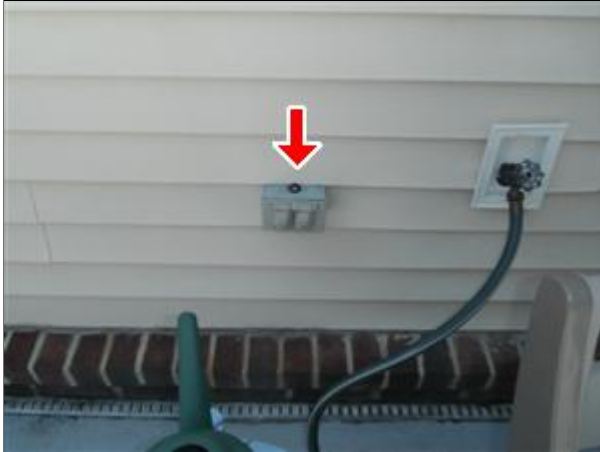
7.5 Picture 1 rear of home

🔧 Two GFCI (Ground Fault Circuit Interrupter) outlets at the exterior wont "trip" when tested. Further inspection is needed by a qualified licensed electrical contractor. I recommend repair as needed.

Two GFCI (Ground Fault Circuit Interrupter) outlets at the exterior wont "trip" when tested. Further inspection is needed by a qualified licensed electrical contractor. I recommend repair as needed.

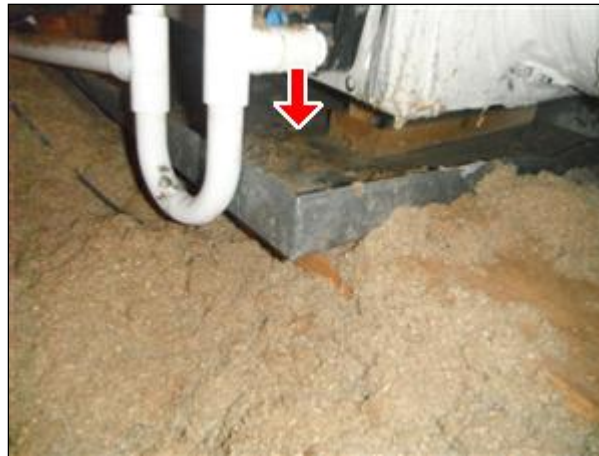
8.0 Picture 1

The air handler in attic needs insulation cleaned away from tray to prevent clogging emergency drain tube. This is for your information.

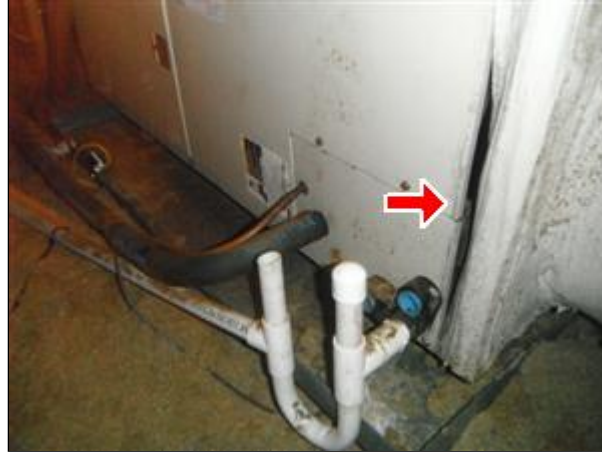
8.3 Picture 1

🔧 The duct tape on the return duct pipe is loose at the air handler in the attic. Energy loss is occurring where duct tape has failed. I recommend a qualified person to repair as needed.

The duct tape on the return duct pipe is loose at the air handler in the attic. Energy loss is occurring where duct tape has failed. I recommend a qualified person to repair as needed.
